# Performance Of West Oxfordshire District Council Office's Photovoltaic Arrays

Christian N. Jardine\*

Environmental Change Institute, University of Oxford, South Parks Road, Oxford, OX1 3QY  
Corresponding Author

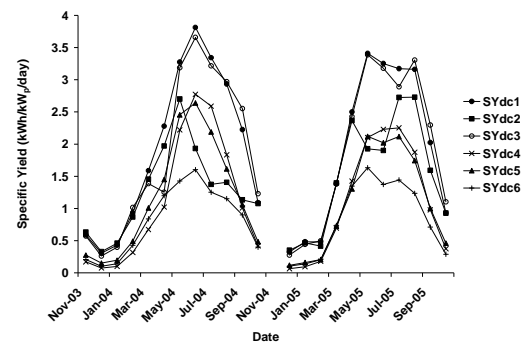
Figure 1. Average Daily specific yields through the year.

There were long periods of zero electricity production due to failed inverters. Of the 18 inverters on site, 2 had failed within the first year of operation, and resulted in 164 inverter-days of downtime. Again, such problems were only spotted due to the presence of a thorough monitoring set-up. The two inverters were replaced by the system installers within 3 month's of notification. These periods of inverter failure have noticeably affected yields on roof 2 (see Figure 1).

As expected the roofs with a southerly aspect outperform those with a northerly aspect. Roof 2 gave a lower yield than expected due to the inverter failures in summer 2004 and 2005 (see Figure 1). Roofs 4 and 5, which both face northwards gave respectable yields of 400 kWh/kWp but due to inverter sizing were inactive for much of the year. Roof 6 yielded just 300 kWh/kWp but is heavily shaded.

Roofs 1 and 3 reach an average daily production in the summer months of 4 kWh/kWp per day. On an individual clear bright day, these roofs are capable of generating up to 10 kWh/kWp per day. Roof 2, should follow a similar output profile, but the inverter failures have severely limited electricity output. The northerly facing roofs also perform impressively well in summer, averaging 3 kWh/kWp per day despite not receiving direct sunshine. This is an indication of the brightness of diffuse light, coupled with longer daylight hours, in the summer months. However, output in the winter months is very low, and hampered by the way the system is sized (see below). Roof 6 performs comparably to other roofs in the winter months, but poorly in summer.

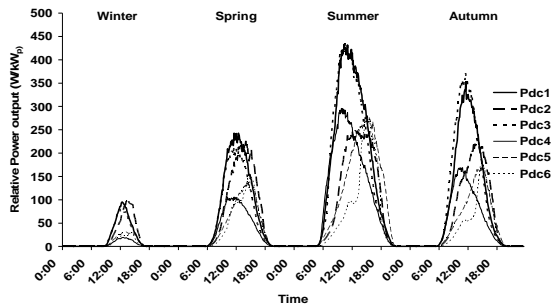
Figure 2. Daily profiles of the six roofs.

Roof 6 is shaded by the building and a tree during the morning and early afternoon, which dramatically reduces output (see Figure 2) by reducing the direct sunshine component received by the roof.

As expected, the roofs with a westerly aspect (2 & 5) reach a maximum in the afternoon, whilst those with an easterly aspect (1, 3 & 4) peak in the morning. Roof 6 also peaks in the afternoon despite being virtually horizontal, due to the extensive shading from the building during the morning. The impressive summer performance of northerly facing roofs 4 and 5 is again apparent.

Shading is observed on roofs 1 and 6. Although the whole of roof 1 is not shaded by the adjacent building, the most heavily shaded string produces just 40% of the electricity of the least shaded. Roof 6 also shows shading from the building in the morning and early afternoon (see Figure 2) making Roof 6 the poorest performing roof.

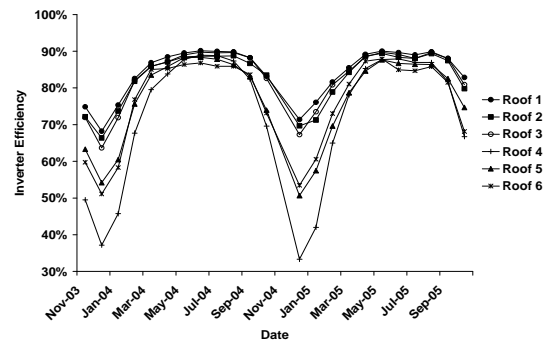
Figure 3. Seasonal Variation of Inverter Efficiencies.

The size of the strings and inverters are shown in Table 1. It should be noted that all inverters are oversized for their arrays, and those with 1.1 kW inverters have all shown severe performance problems. Oversizing of inverters is a debatable practice in maritime climates where inverters should be marginally undersized for optimum performance as very high insulations are not observed[2]. The DTI Installation guidelines[1] suggest that inverters should be between 0.8 and 1 times the size of the string. This is especially true at the Witney site where none of the roofs have an optimal orientation and so do not receive maximum insolation. Roofs 4 and 5 do not receive insolation of more than  $800 \text{ Wm}^{-2}$ , meaning the inverter is oversized by approximately 50%.

First, the inverters spend more time operating in their low efficiency range at low power inputs, meaning that electricity generated by the PV array is not converted to useable AC electricity.

Second, inverters require a certain amount of input power to turn on. If the inverters are oversized higher insulations are required to achieve this. Therefore, the operational time of each array is reduced. One string on roof 4 did not turn on at all in December 2005. Combining these two effects results extremely low inverter efficiencies (Figure 3) in the winter months in those roofs with a northerly aspect - roof 4 averages just 33% in December 2004.

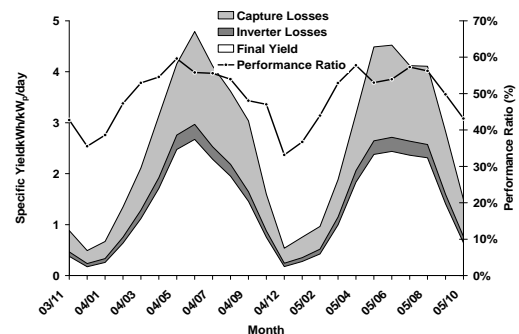
Figure 4. Capture and system losses, and performance ratio throughout the year

The array capture losses (see Figure 4) from the strings are a significant factor in the low performance ratios observed at the Witney site.

There are several possible reasons for this including shading, inverter malfunction, the inverter oversizing, inverter tracking and the PV roofing product itself. These are discussed in more detail below.

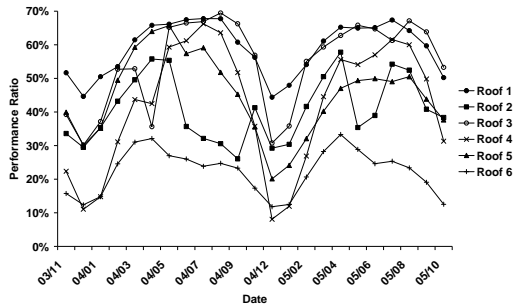
Figure 5. Average Performance Ratios for each of the roofs.

The specific yields of the system were low, being 529 kWh/kWp DC and 469 kWh/kWp AC, although there is a variation between the roofs (See Table 2). However, none of the arrays are optimally oriented, so yields from this system were expected to be lower than the typical UK values of 750-800 kWh/kWp [1]. Normalising by insolation received, the performance ratios are also low, averaging 48% compared to 70-80% for a well-performing system. Reasons for the underperformance are explained in more detail below.

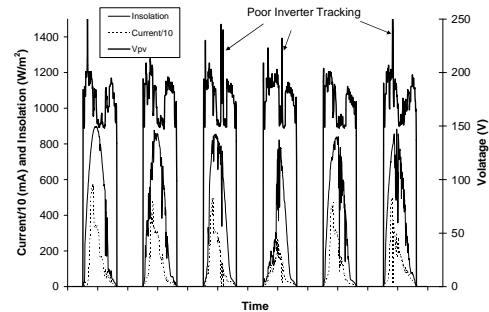
Figure 6. Inverter tracking on string 1\_1 between 01/09/04 and 06/09/04.

Poor inverter tracking has been observed and can be detected by a surge in voltage and dramatic drop in current, or vice versa - in each case the power will drop off dramatically from the desired maximum power point. The power output profile will also no longer be the same shape as the insolation profile. Voltage spikes due to poor inverter tracking are clearly visible in Figure 6. However, even during periods of good operation, there is clearly some movement around the maximum power

point, with a spiky voltage profile. The current is also no longer proportional to the insolation. The SMA inverters have a history of poor tracking of amorphous silicon arrays[4] and this may be the case here. However, it is not possible for the present monitoring set-up to determine this as the inverter is both maximum power point tracker and measurer of current and voltage values.
